**Management Survey
(with MA and PA) to
Annex Only**

London Borough of Camden
5 Pancras Square
London
N1C 4AG

**194a Goldhurst Terrace
London
NW6 3HN**

Report issue date:	4 Sep 2019

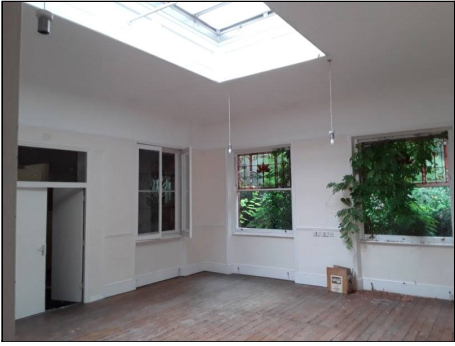
Survey Date:	Lead Surveyor	Survey Type	Floor	Analysis
	28 Aug 2019	Jim Chapman	Management Survey	Ground Floor	N/A
	Building	Room	Item	Quantity	
	194a Goldhurst Terrace	G.01 G01	No suspect materials found	N/A	
	Sample No (S,SP,P,As)	Product Type	Surface Treatment	Condition	Accessibility
	Visual (P)	N/A	N/A	N/A	N/A

Normal Occupancy	Score	Likelihood of disturbance	Score	Exposure Potential	Score	Maintenance Activity	Score
Main type of activity	N/A	Location	N/A	Number of occupants	N/A	Type of Maintenance	N/A
		Accessibility	N/A	Frequency of use	N/A	Frequency of maintenance	N/A
		Amount	N/A	Average Time	N/A		
Average Score	N/A	Average Score	N/A	Average Score	N/A	Average Score	N/A
Average of Priority	N/A						
Material Assessment Score	N/A						
Recommendation	No further action required

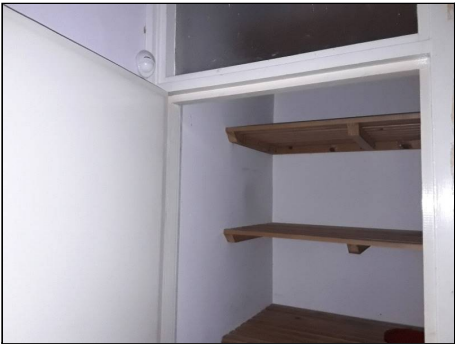
Survey Date:	Lead Surveyor	Survey Type	Floor	Analysis
	28 Aug 2019	Jim Chapman	Management Survey	Ground Floor	N/A
	Building	Room	Item	Quantity	
	194a Goldhurst Terrace	G.03B G05	No suspect materials found	N/A	
	Sample No (S,SP,P,As)	Product Type	Surface Treatment	Condition	Accessibility
	Visual (P)	N/A	N/A	N/A	N/A

Normal Occupancy	Score	Likelihood of disturbance	Score	Exposure Potential	Score	Maintenance Activity	Score
Main type of activity	N/A	Location	N/A	Number of occupants	N/A	Type of Maintenance	N/A
		Accessibility	N/A	Frequency of use	N/A	Frequency of maintenance	N/A
		Amount	N/A	Average Time	N/A		
Average Score	N/A	Average Score	N/A	Average Score	N/A	Average Score	N/A
Average of Priority	N/A						
Material Assessment Score	N/A						
Recommendation	No further action required

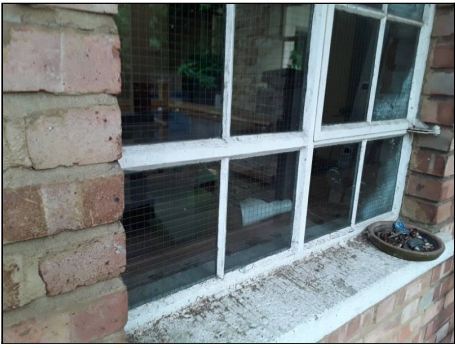
Survey Date:	Lead Surveyor	Survey Type	Floor	Analysis
	28 Aug 2019	Jim Chapman	Management Survey	External	No Asbestos Detected
	Building	Room	Item	Quantity	
	194a Goldhurst Terrace	E.01 E01	Putty to metal framed windows Metal framed windows	20lm	
	Sample No (S,SP,P,As)	Product Type	Surface Treatment	Condition	Accessibility
	KW000779 (S)	N/A	N/A	N/A	N/A

Normal Occupancy	Score	Likelihood of disturbance	Score	Exposure Potential	Score	Maintenance Activity	Score
Main type of activity	N/A	Location	N/A	Number of occupants	N/A	Type of Maintenance	N/A
		Accessibility	N/A	Frequency of use	N/A	Frequency of maintenance	N/A
		Amount	N/A	Average Time	N/A		
Average Score	N/A	Average Score	N/A	Average Score	N/A	Average Score	N/A
Average of Priority	N/A						
Material Assessment Score	N/A						
Recommendation	No further action required
